primo

COMPACT

ERRORS - NO ERROR CODE RELATED PROBLEMS

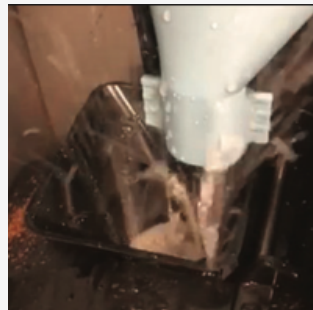
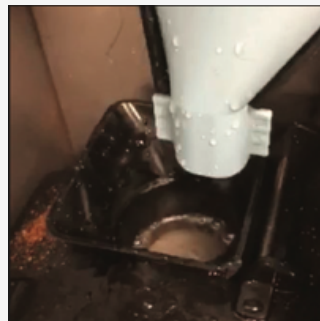
Valve DV6 which is located just before the brewer inlet does not open after the brewing cycle.

Valve DV6 is located just below the brewer motor and can be reached from the inside by removing the rear panel.

The valve can be taken apart completely and the interior cleaned. Or replace the valve entirely.
