primo

COMPACT

NON ERROR CODE RELATED ISSUES

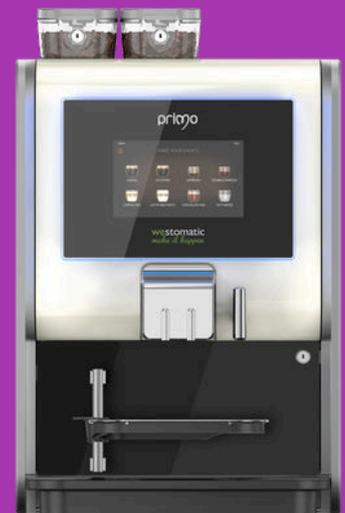
No coffee is brewed. Water ejecting straight in the drip tray during coffee brew process.

When the brewer return to it home position water sprays up from the brewer cylinder, see picture.

Valve DV6 which is located just before the brewer inlet does not opens after the brewing cycle.

Valve DV6 is located just below the brewer motor and can be reached from the inside by removing the rear panel.

The valve can taken apart completely, see the instructions hereafter.

Clean the interior or replace the valve.

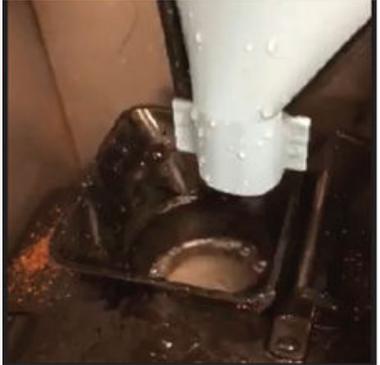
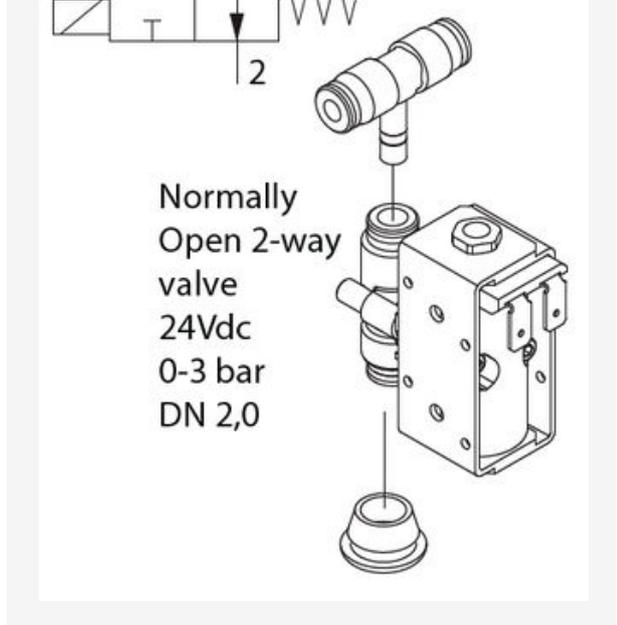
When the brewer has reached its home position water stays behind in the brewer cylinder.

This water results in wet and sticky coffee pucks when it's discharged from the brewer.

Valve DV6 which is located just before the brewer inlet does not opens after the brewing cycle.

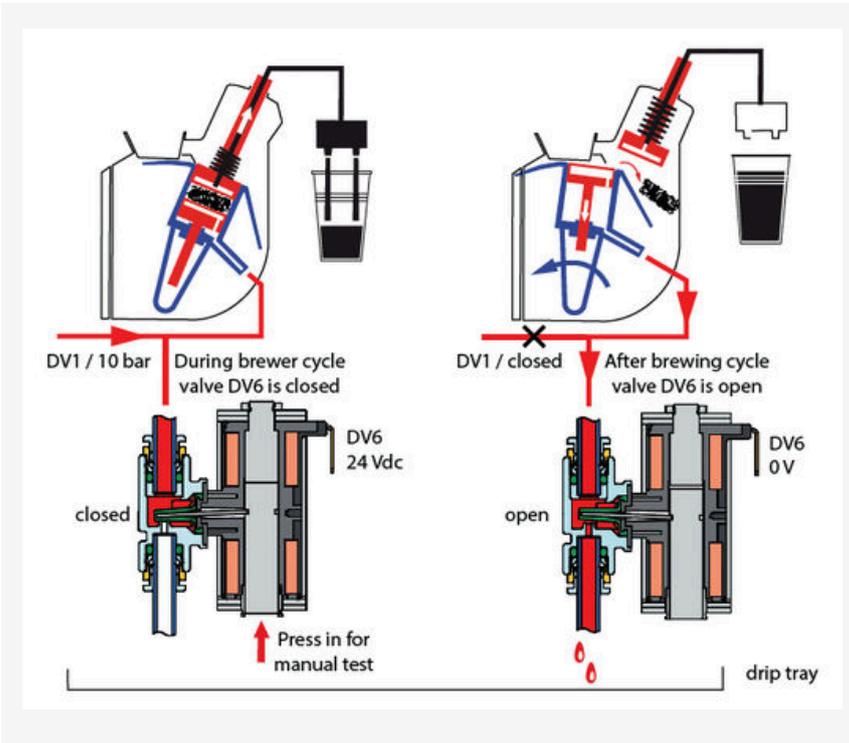
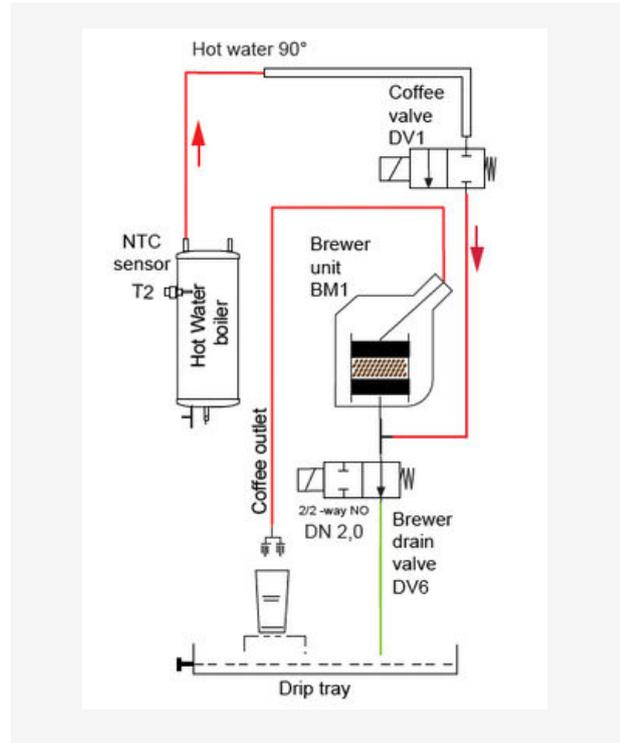
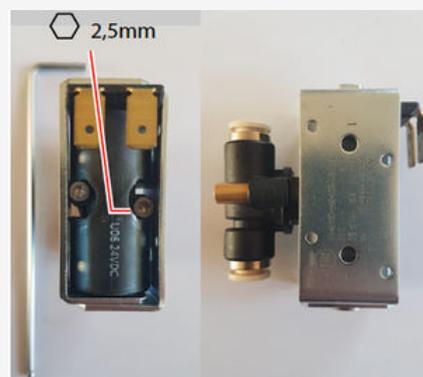
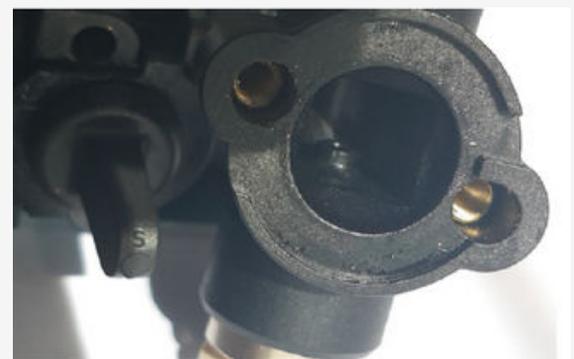
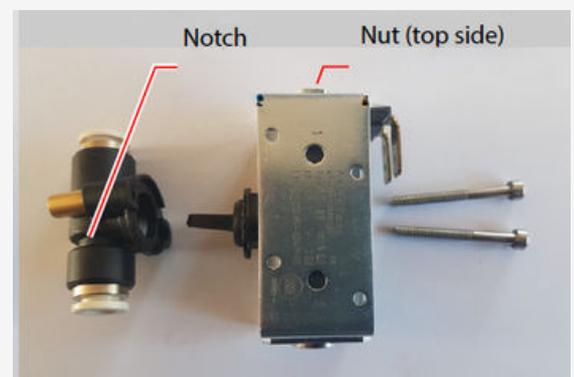
Valve DV6 is dirty.

To clean the valve:

Disassemble the coil from the body.

Clean the silicon lever and the inside of the valve body.

Pay attention to the notch position when assembling the valve.

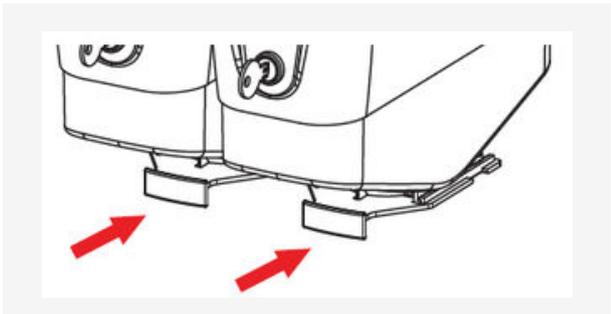
Grinder motor runs but no ground coffee comes out.

Check whether the bean slide of the bean container is fully open.
Slide(s) must be pressed in.

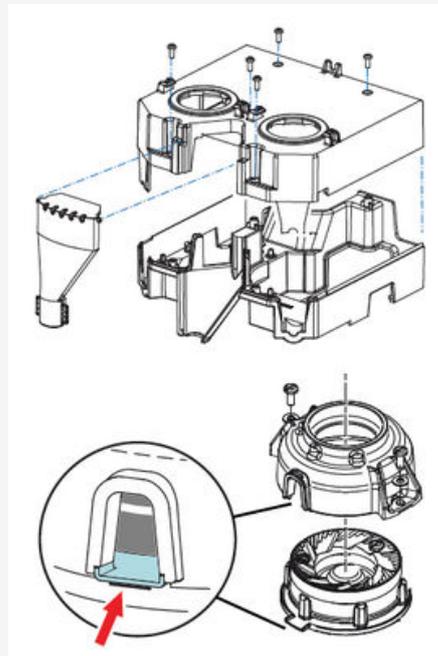
The coffee grinder is jammed by a foreign object.

Disassemble the upper part where the grinder(s) are build-in.

Disassemble the top half of the coffee grinder.

Vacuum / brush away all coffee residues and check the grinding discs for damage.

If necessary, clean the grinding wheel grooves with a copper wire brush.

Refit the top and test the grinder.

Ensure that the plastic disc is back into the recess after installation, see picture.

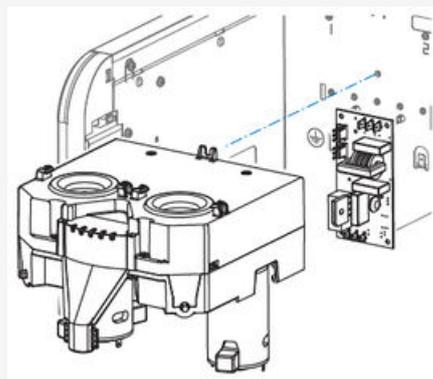
The grinder PC board does not operate.

To reach the grinder PC board the complete grinder housing must be removed.

There is one screw hidden behind the left panel. The second screw can be reached from the front.

Now the complete grinder 'box' can be tilted out of the machine from the front.

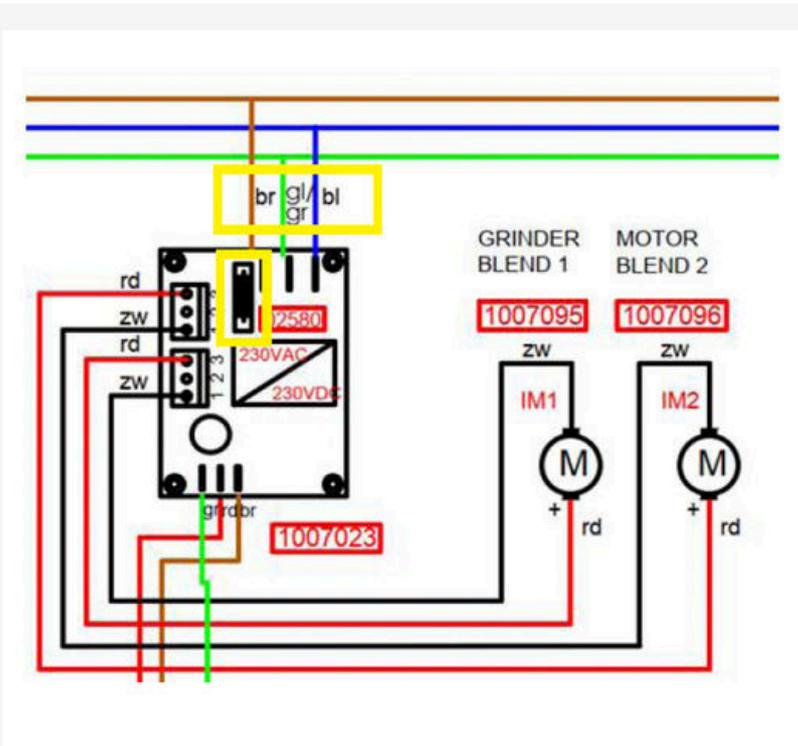
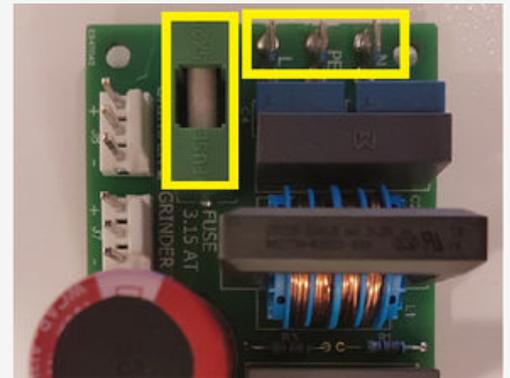
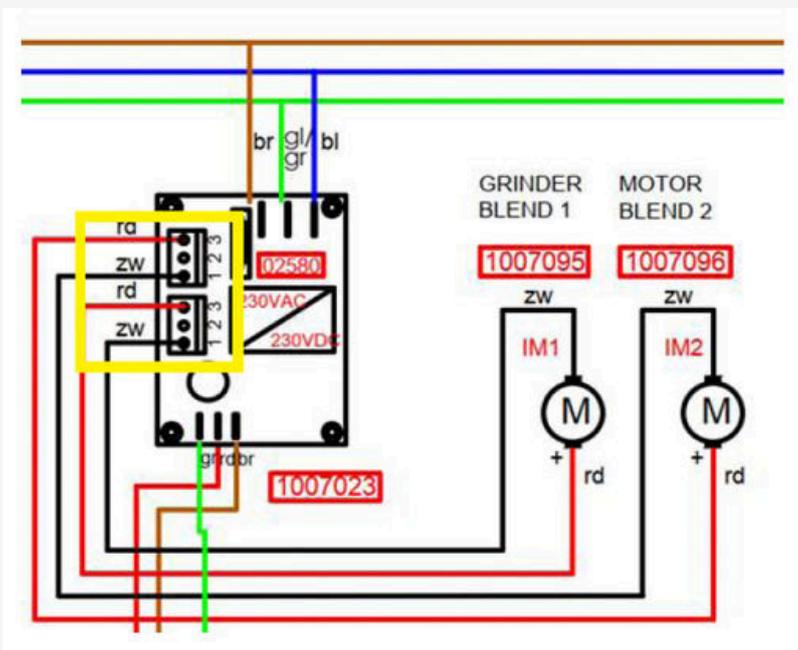
Please check the following connections and signals.

Power (top); The grinder board must be connected to the 230Vac brown and blue.

Fuse: the fuse secures the Phase, 3,15A (T)

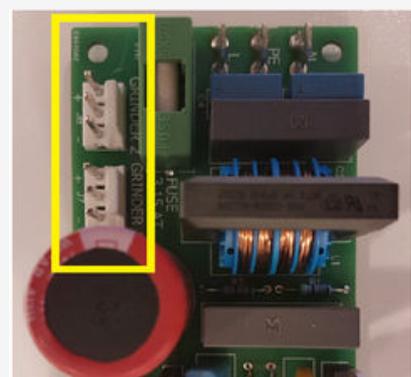
Grinder motor(s); both motors (230Vdc) must be connected on the two (2) pin connectors.

Top left connector is IM2 motor (blend 2)

Bottom left connector is IM1 motor (blend 1)

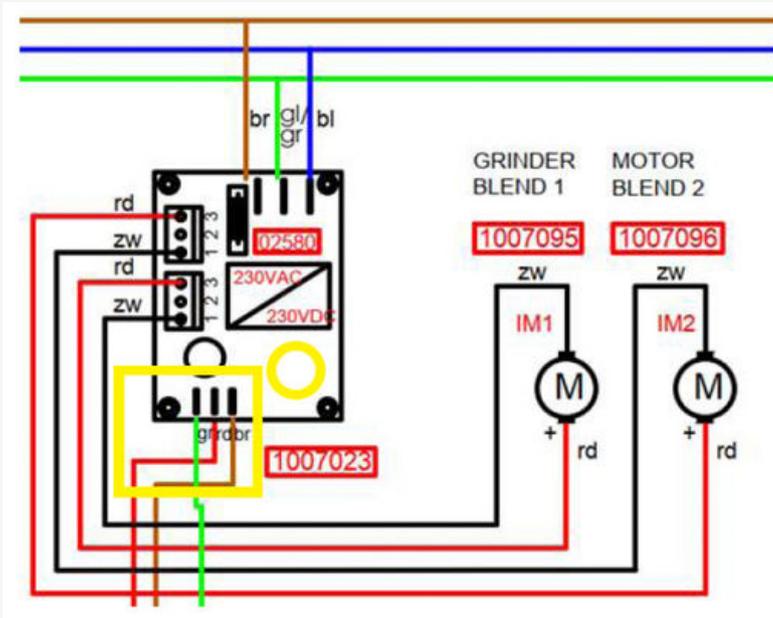
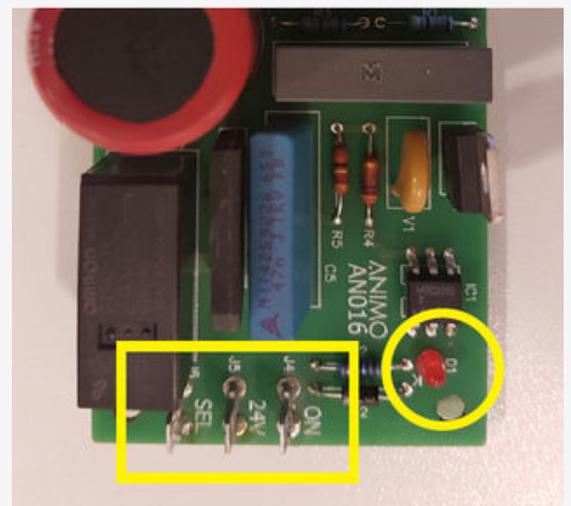
LED; the LED lights up when one of the grinder motor signals are activated.

Signals; from the I/O board

Red; 24V from the I/O Platine.

Brown; Signal to start grinder motor 1 (left grinder).

Green; Signal to start grinder motor 2 (right grinder) *

* Grinder motor 2 is controlled under the following condition:

First a signal on Green arrives from main board IM2 (you must hear a click from the relay on the grinder board) + delayed signal on Brown from main board IM1 to start motor 2.
